Primodan focuses on ROTOBLOCK

The indexing gear in your filling and dosing machine.

Lack of maintenance can result in accidents and work stoppages!

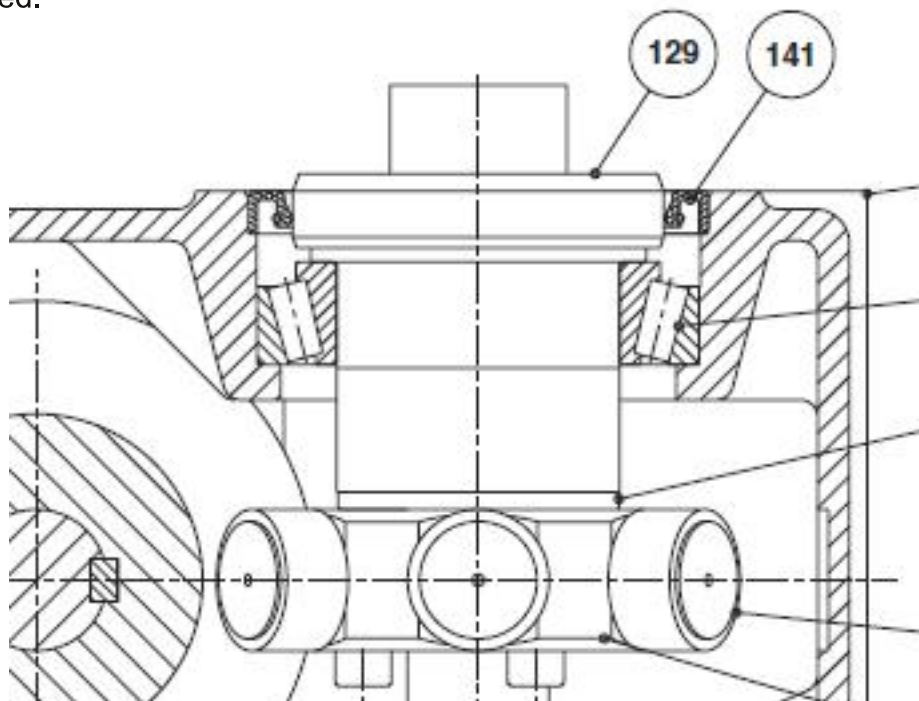
Rotoblock indexing gears are in principle filled by the quantity and quality of oil for operation throughout the life of gear. At said customer fluid was entered into the gear unit, which thus became overfilled, because of leakage in a sealing ring (Service Handbook Item 141). The gear was "smeared" by a mixture of water, cleaning fluid and oil. The result was that gear stuck and had to be repaired.

We therefore urge all our customers to check their Rotoblock indexing gear for similar problems before it becomes critical.

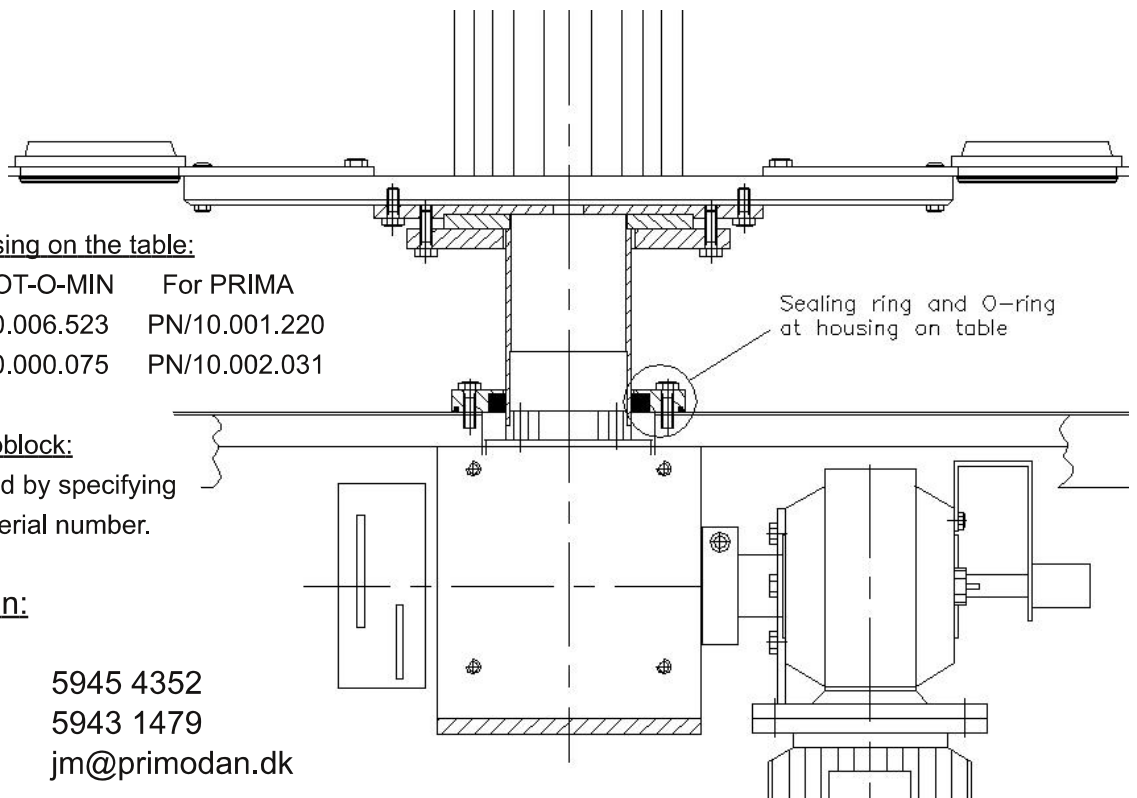
If there is a large amount of fluid, and it seems like there is water in the oil, the oil sealing ring is probably leaking and water has penetrated into the gear. (oil + water = "mayonnaise")

In this case the Rotoblock must be removed from the machine and cleaned, checked and renovated. The sealing ring for the roundtable shaft at the housing on the table should also be replaced during this operation.
